Perennially Problematic Peugeots

By Mike Weinberg
Contributing Editor

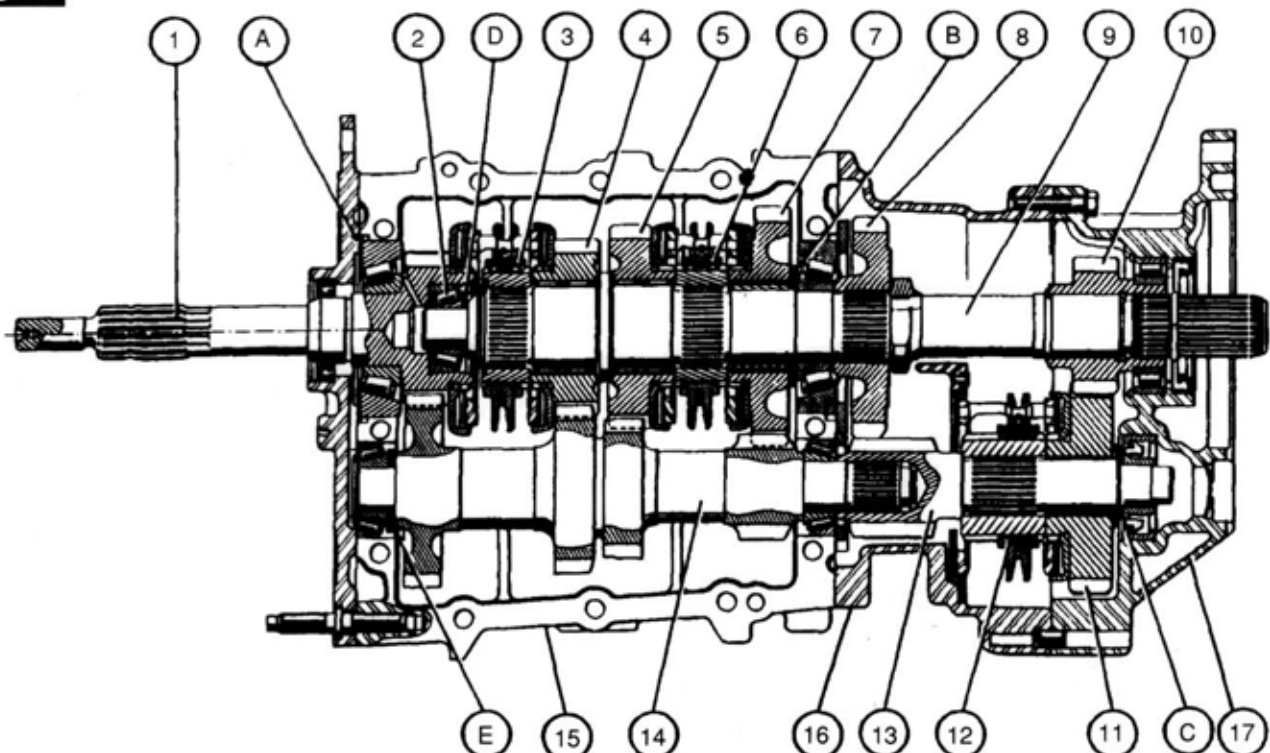
fig. #1

Endplay and preload are maintained by shims in front of or under the main bearings. See the letter key in the cutaway schematic (Figure 2). In many cases, these shims are accompanied by a thrust washer. A real time saver is to take some plastic ties and keep the bearing, race, shim and washer together for easy measurement and reassembly. At the nose of the mainshaft is a tapered bearing similar to the ZF design in Ford trucks. Be aware that under the bearing is a selective shim to maintain mainshaft endplay.

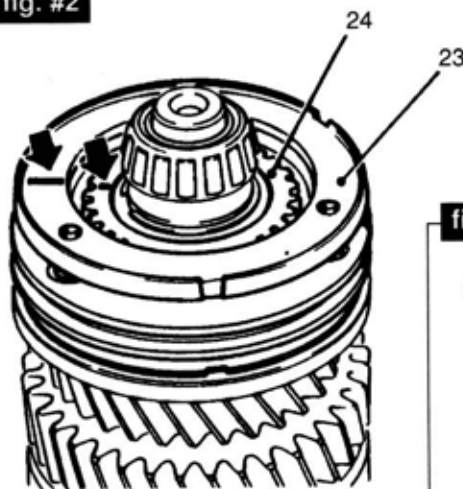
fig. #2

gear oil as the factory lube, cold-shifting is tough. Switching to 20-50W synthetic motor oil helps, but is not a complete cure. The main culprit is the synchronizer design and capacity. This unit is equipped with pin-type synchros, last used in the NP435. An antique design, pin-type synchros are prone to loose pins, slider hang-up (hard shifts), and are extremely sensitive to endplay. When tearing down one of these units, you **MUST** mark the hub and slider to index them for reassembly (See Figure 1). Failure to do so will make shifting go from bad to worse.

Mark the third-fourth synchronizer and hub for assembly reference. Then remove the synchronizer (24) from the hub (23).

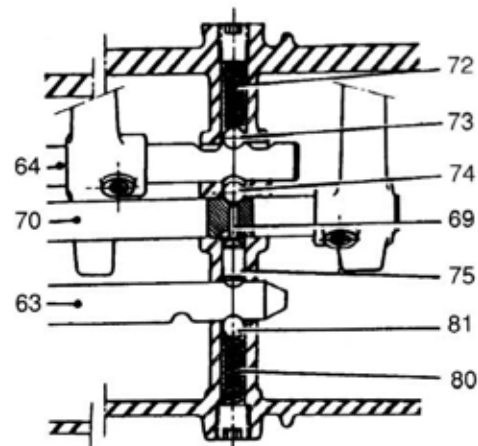
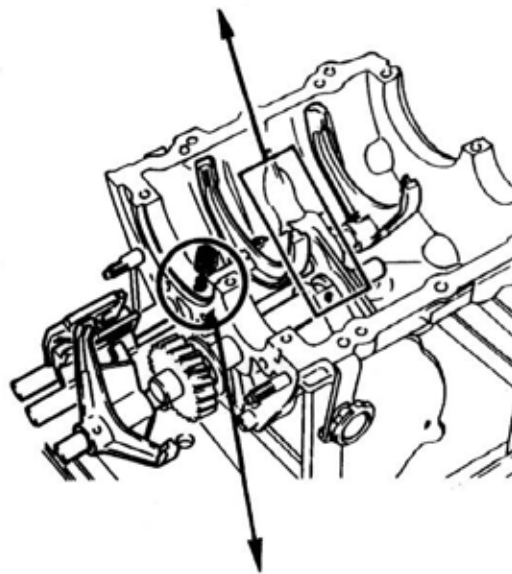
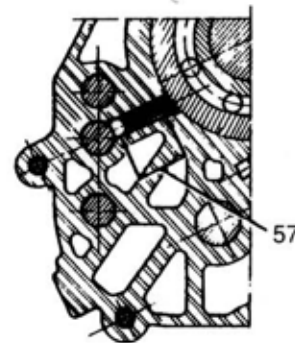
fig. #3

bore under the rear mainshaft bearing (#57 in Figure 3). If you don't take care on disassembly, they will march on. When reassembling the 5th-gear fork, be careful not to over-travel the 5th-reverse rail, as the detent ball will escape into the case and you will have to take the main case apart again. The 3-4 shift rail has a thin interlock pin running through it (#69 in Figure 3), which is easily lost in handling.
