Handling 6-Speed Heavyweights

**By Mike Weinberg
Contributing Editor**

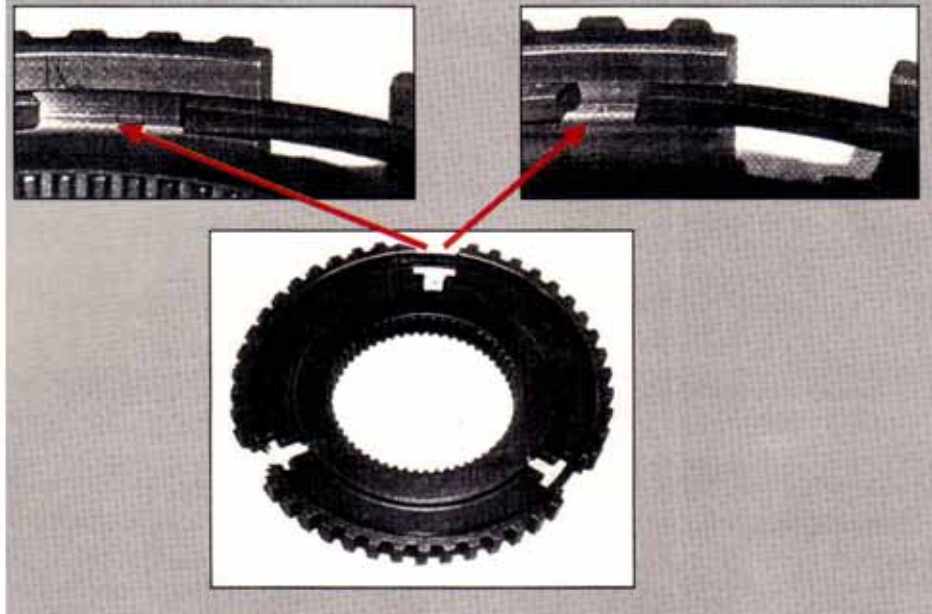
Figure 4

The 5th-gear synchronizer hub on this unit is equipped with a snap ring to retain the pressure pieces (synchro keys) in position during shifts (see Figure 4). The first-design snap ring was produced with a gap that was too large. Occasionally the snap ring will rotate in the synchronizer hub during use and the gap will line up with the opening for the synchro key. When this happens, the key will move through the gap in the

5th Gear Synchro Body Snap Ring Update

retaining ring and either fall out or jam the synchronizer. A redesigned synchro hub now available has a longer retaining ring, which prevents the key from moving through the gap. On all internal repairs, compare the 5th-gear synchro retaining snap ring to the pictures shown here. If your ring has the wide opening, replace it with the later design.
