N issan, formerly Datsun, has a good-sized share of the car market. The Maxima front-wheel-drive model uses a very smooth-running V-6 motor and a good-shifting five-speed manual transaxle. Although we tend to call this unit a "Maxima five-speed," its real designation is the RS5F50A. Introduced in 1985, this unit is found in all standard-shift Maximas through 1992. A variation of this transmission,

Maximum Maxima

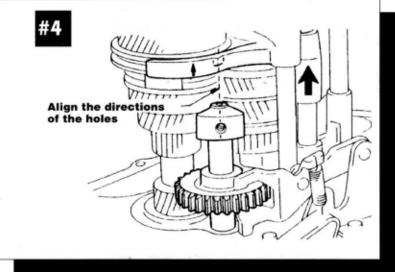
The reverse-lever assembly actuates the reverse-idler gear when reverse is selected. There are two holes in the reverse arm. The hole to the left is where the reverse-arm shaft is anchored (See Figure 3). The hole to the right houses the reverse checkball, which

usually falls out on tear down. Before assembly of the case halves, remember to line up the reverse-idler shaft so that the reverse-idler shaftretaining bolt will line up with the cases together (See Figure 4). The unit is sealed with RTV and there are no gaskets.
